Re Input on Proposed Harmonisation Docs – 23rd PPIHWG Montreal

Ref. 991116/16 - 25.903(e) Inflight Starting
Attachment 11

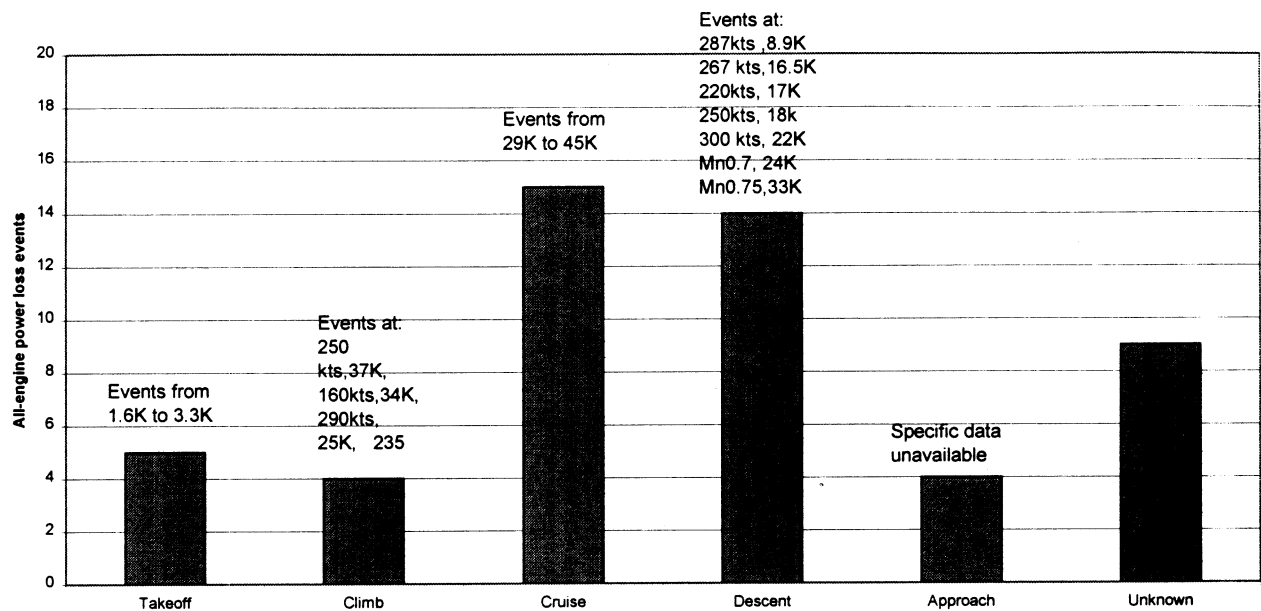
CHART 2
Commercial Transport Fleet All-Engine Power Loss Events, by Flight Phase
1960-1996

**Majority of events occur at high/intermediate altitudes.
Low altitude/low airspeed/low power scenario (condition 4)
represents no events/ a very small proportion of events**

The flight conditions specified in the AC do not reflect the flight conditions at which the majority of all-engine power losses have historically occurred, according to this database. Specifically, condition 4 (low power, below 10,000 ft, 1.45 V_{stall}) reflects a more severe condition than has been documented for an all-engine power loss in the commercial transport fleet. It is proposed that the requirement of section 7, condition 4, for an initial airspeed of 1.45 V_{stall} be changed to permit a higher initial airspeed such as 250 kts.
